Video Analysis of NIST's Claim of a 5.4 s Collapse Time Over 18 Stories for WTC 7

Jeremy R. Hammond

July 2011

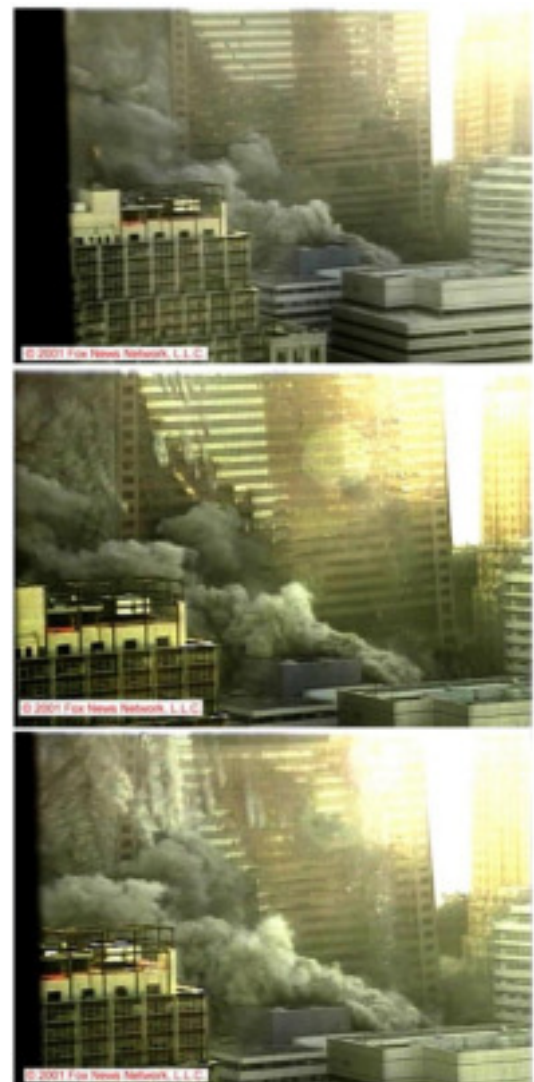
Figure 1

However, this is problematic because any movement of the center roofline at this stage could indicate lateral displacement of the north façade southward due to it being pulled inward as a result of the collapse of the core. Lateral displacement *away* from the point of view of the camera could be *perceived* as "downward" displacement, but not actually representative of the beginning of downward movement, and thus not an accurate means by which to determine the onset of global collapse. It seems highly unlikely that the analysts at NIST would not have considered this and been aware of this ambiguity. Moreover, it was explicitly brought to their attention. In public comments on the NIST presentation "WTC 7 Technical Approach and Status Summary" on December 12, 2006, Retired FDNY Battalion Chief Arthur Scheuerman stated that the collapsing core was "pulling in the entire exterior façade." He reiterated, "As the core failed, the perimeter walls were pulled inward, with the greatest deflection at the top floors."¹⁰ A video of the collapse taken from a different angle very clearly shows significant pull-in of the north face as global collapse is underway. Stills from this video were included in the NIST report (**Figure 1**).¹¹

Figure 6 - At frame 310 ("1.0 s" at 10.344 s), the displacement of the center of the roofline has become quite apparent even in still frame. The northwest corner (right) shows no displacement. The northeast corner (left) is showing lateral, but not vertical, displacement. The perception is eastward movement, but presuming the width of the north face has not increased, this must be illusory and the displacement is actually northward. This conclusion is supported by visual evidence of northward leaning of the northeast corner during collapse (see **Figure 1**).

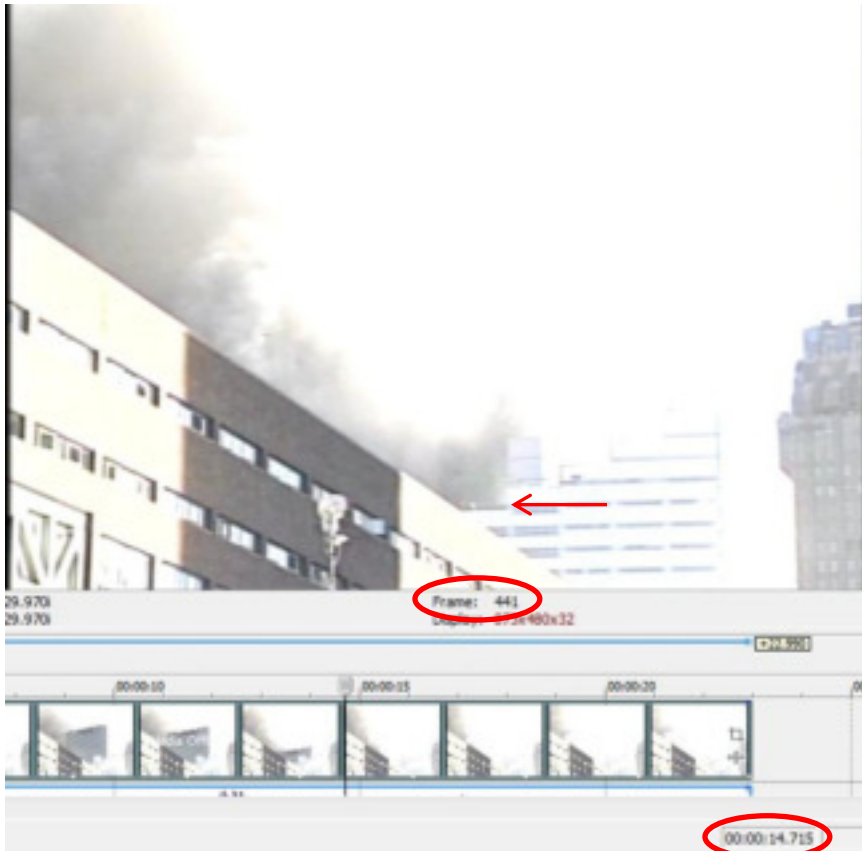
Figure 2 - The last frame WTC 7 is visible in the video was first determined. At frame 441, 14.715 s into this copy of the video, the roofline is still just visible.

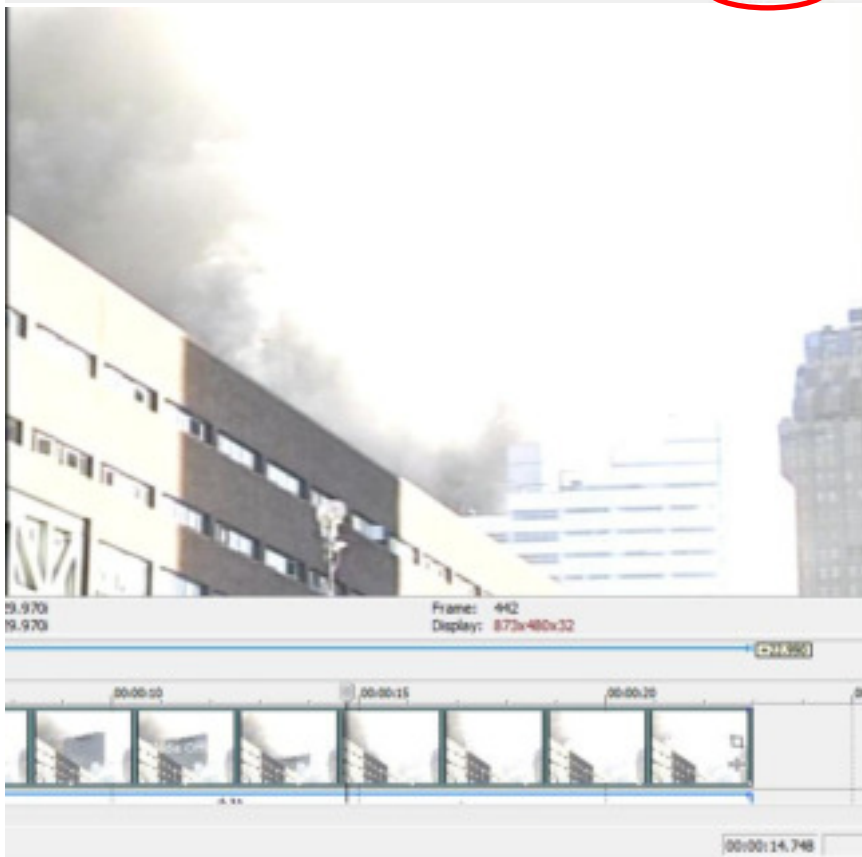
Figure 3 – The roofline is no longer visible in frame 442 at 14.748 s. NIST states it used the last frame the roofline is visible (i.e., frame 441). However, frame 442 was chosen as representing NIST's "5.4 s" into global collapse to err on the side of conservatism (that is to say, giving NIST the benefit of the doubt on its start time by one frame).

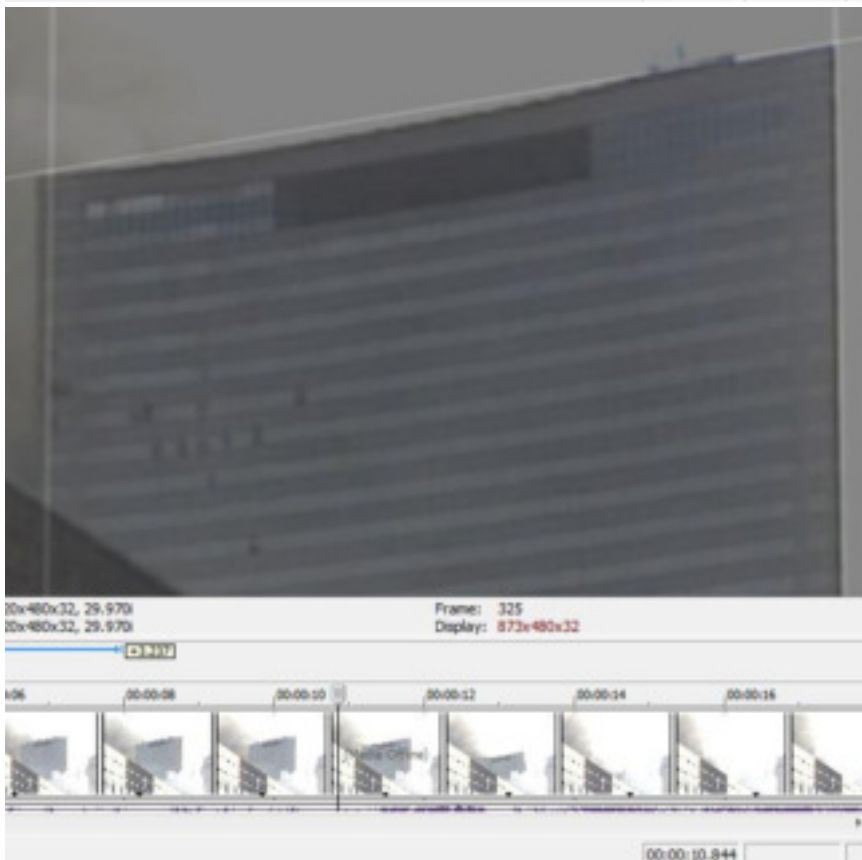
Figure 7 - At frame 325 ("1.5 s" at 10.844 s), the displacement towards the center of the roofline is dramatic. There remains no apparent displacement of the northwest corner at this magnification (see also Figure 21). Lateral displacement of the northeast corner has increased, but still no unambiguous vertical displacement is apparent.

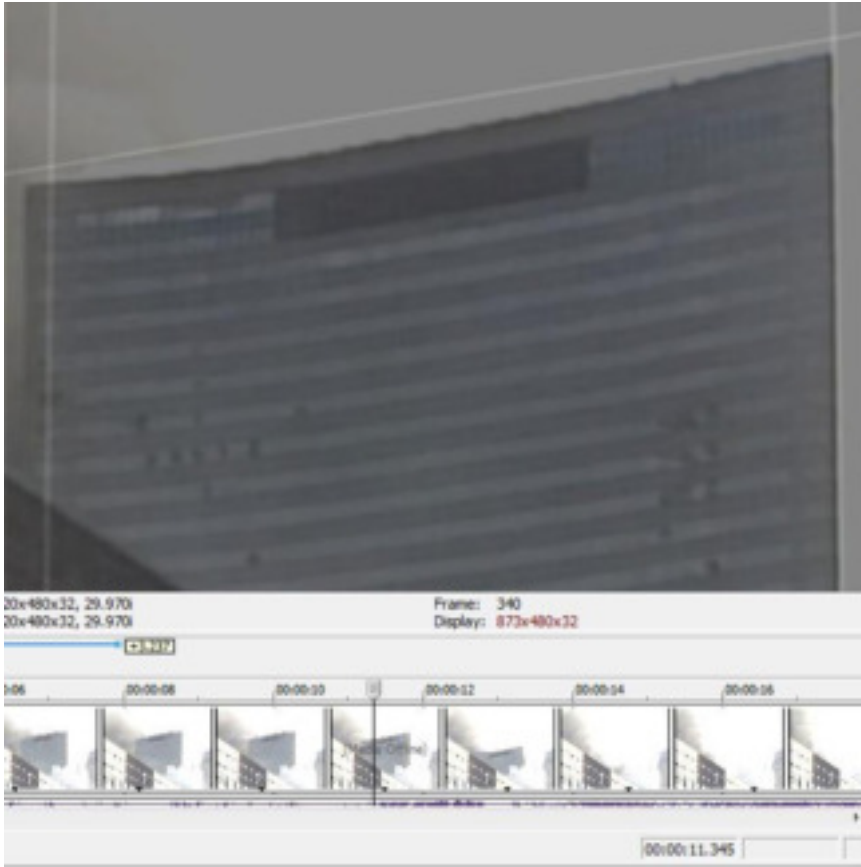
Figure 8 - At frame 340 ("2.0 s" at 11.345), significant vertical displacement is apparent along the entire north face, including both northwest and northeast corners. Global collapse is underway.

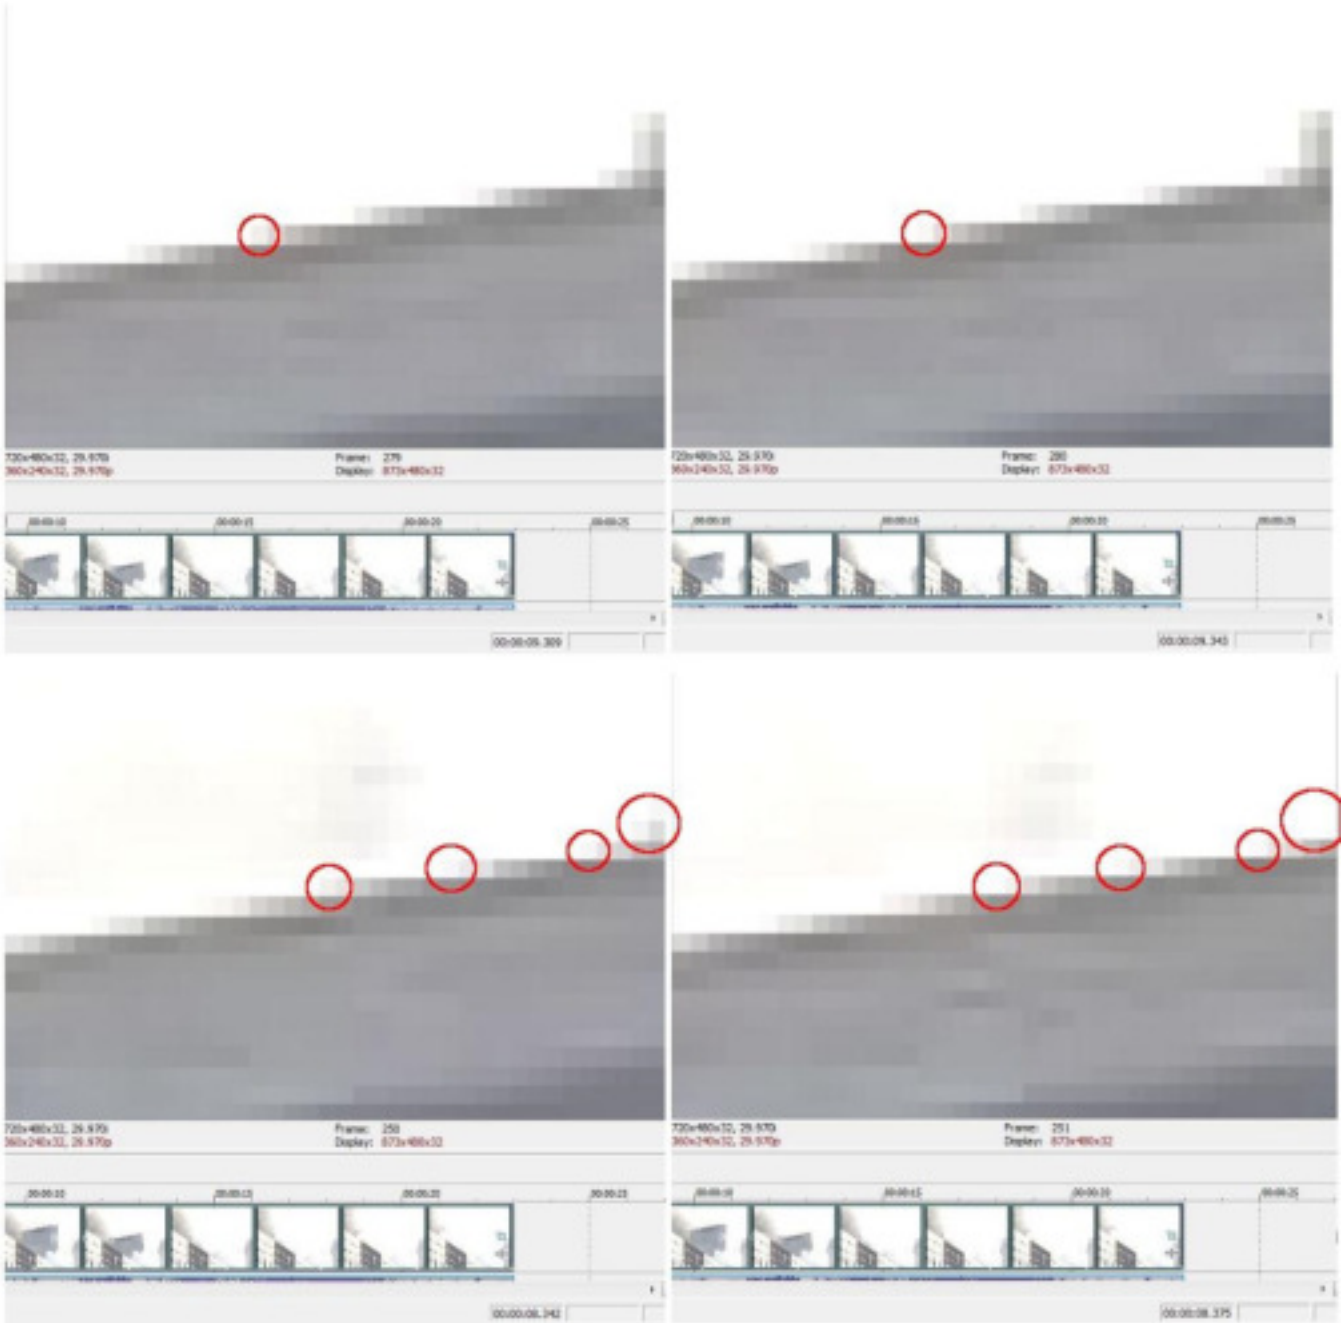
Figure 9 - Magnification was increased towards the center of the roofline to examine for single pixels that brighten, to the extent that the pixel could be said to represent sky rather than the roofline. A pixel that has brightened between frames 279 (9.309 s, top left) and 280 (9.343 s, NIST "0.0 s", top right) is circled. However, NIST's starting time for global collapse seems arbitrary, inasmuch as movement is noticeable by scrubbing the video significantly *prior* to frame 280. Between frames 250 (8.342 s, bottom left) and 251 (8.375 s, NIST "-0.97 s", bottom right), chosen arbitrarily to illustrate the point, numerous pixels are observed to brighten significantly, so as to be indistinguishable from the sky.

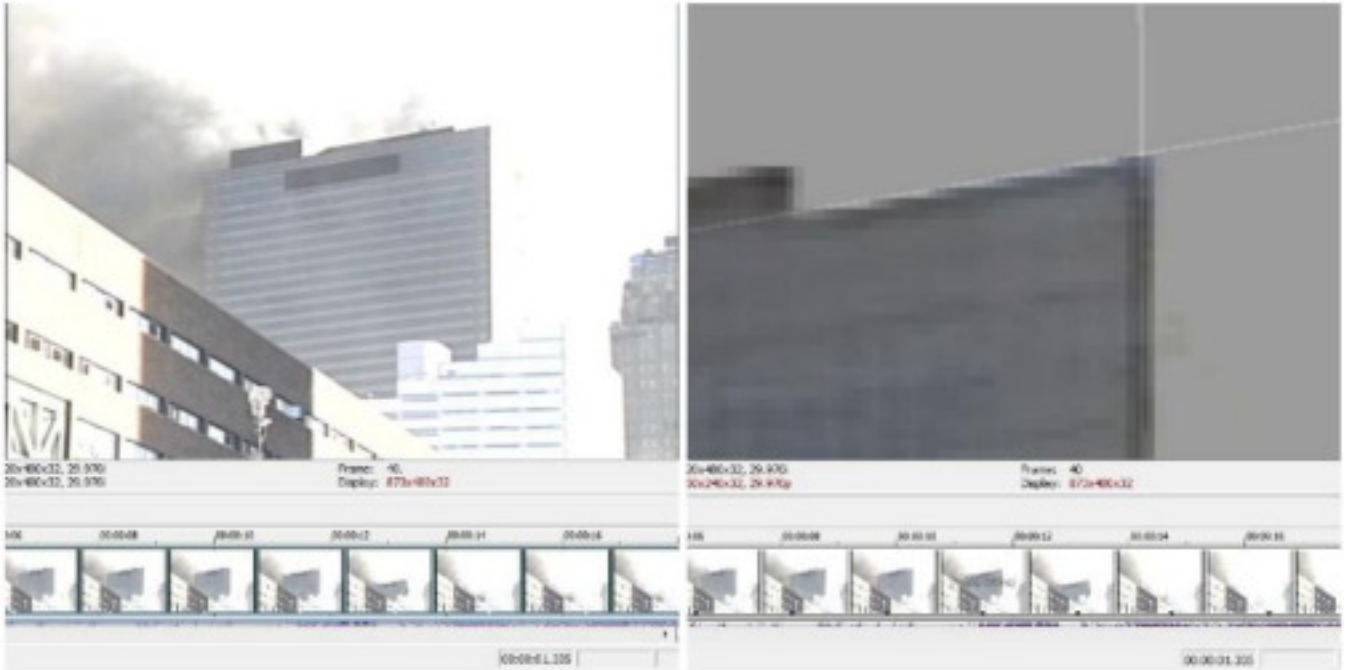
Figure 10 – Further observations were also made of the northwest corner, which was seen to oscillate side-to-side when scrubbing. Magnification was increased so that individual pixels are distinguishable. At frame 40 (1.335 s, NIST "-8.01 s"), the east penthouse has not yet begun to collapse, and a baseline for the northwest corner is established from which to determine subsequent displacement.

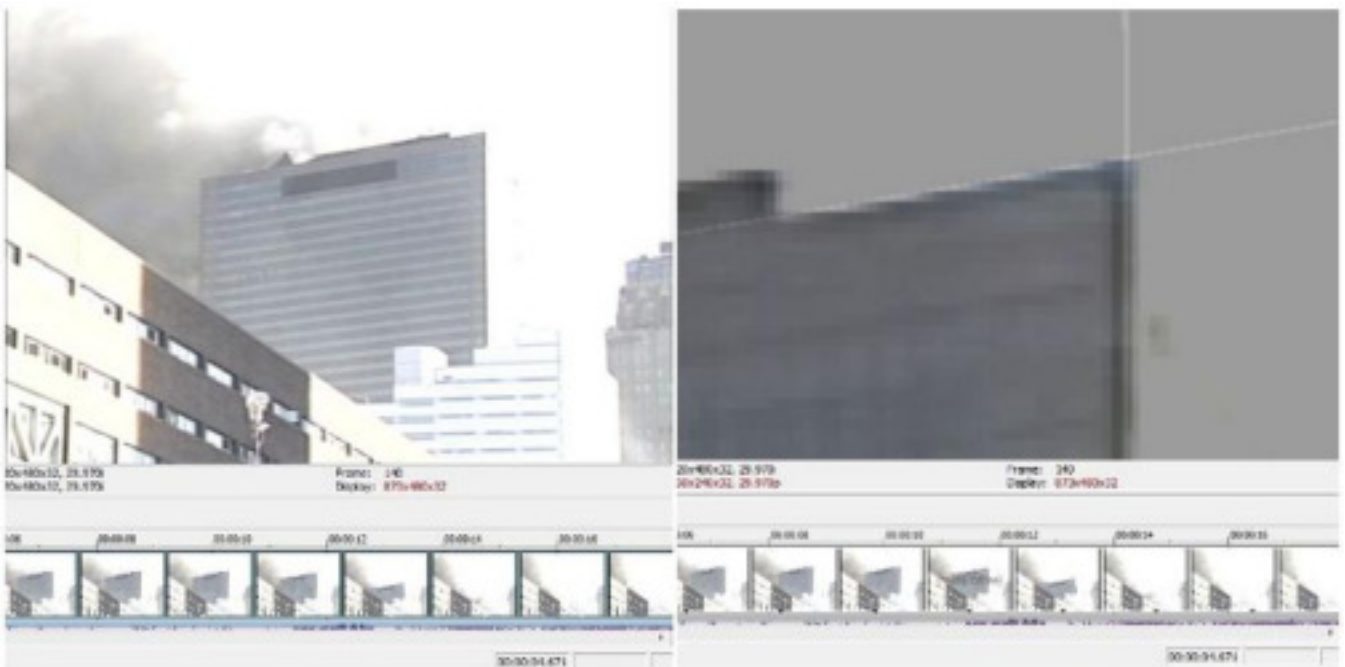
Figure 11 - At frame 140 (4.671 s, NIST "-4.67 s"), collapse of the penthouse is underway. The northwest corner is showing eastward (towards the left) lateral displacement.

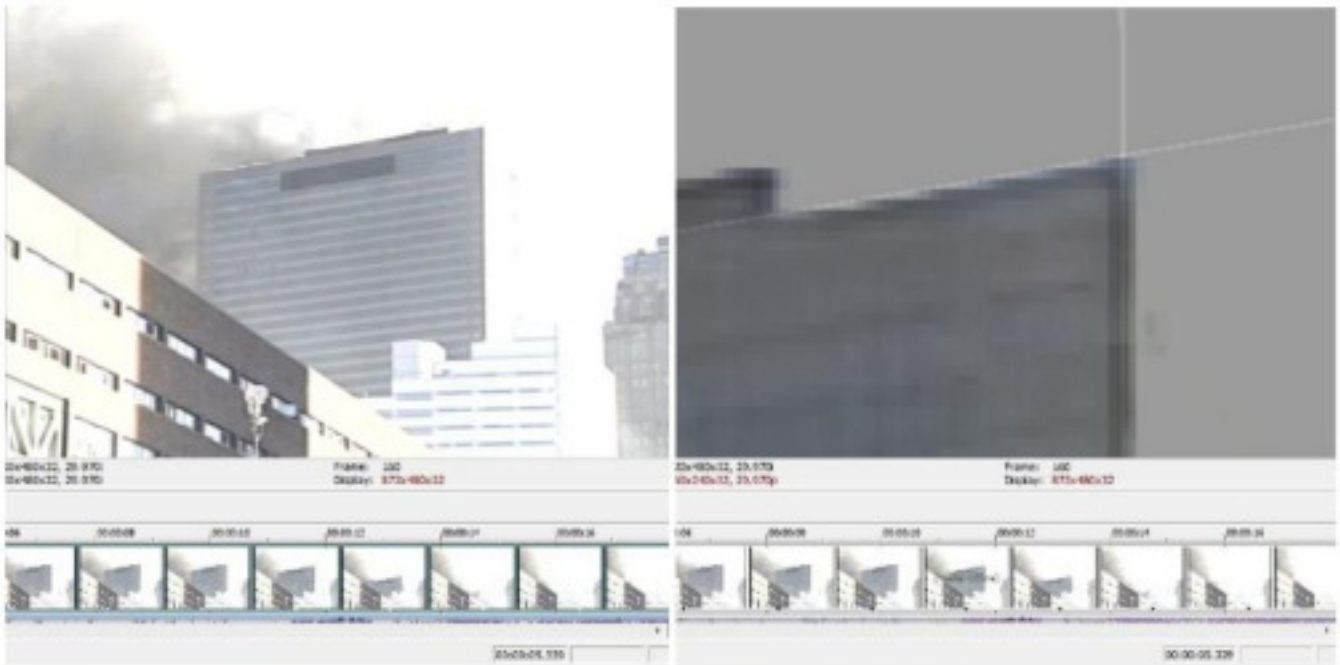
Figure 12 – At frame 160 (5.339 s, NIST "-4.00 s"), the east penthouse has disappeared. The northwest corner has oscillated back to its baseline position.

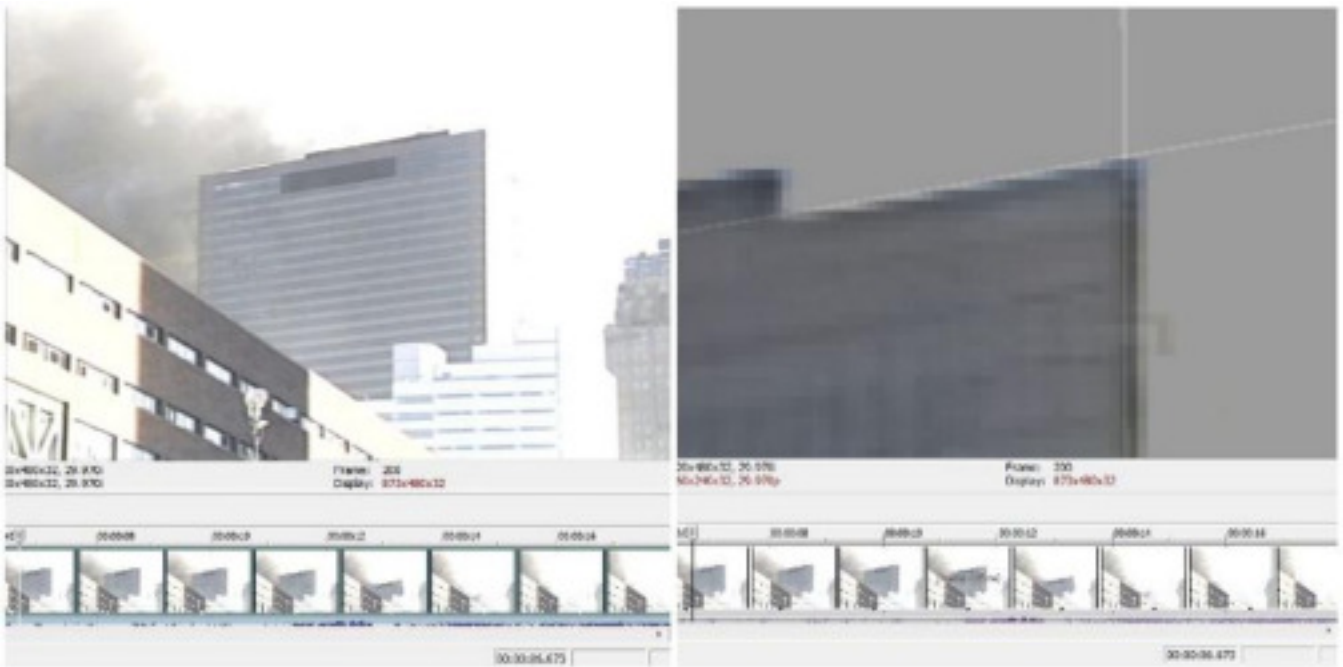
Figure 13 – At frame 200 (6.673 s, NIST "-2.67 s"), the northwest corner has continued to move so that it is now showing westward displacement.

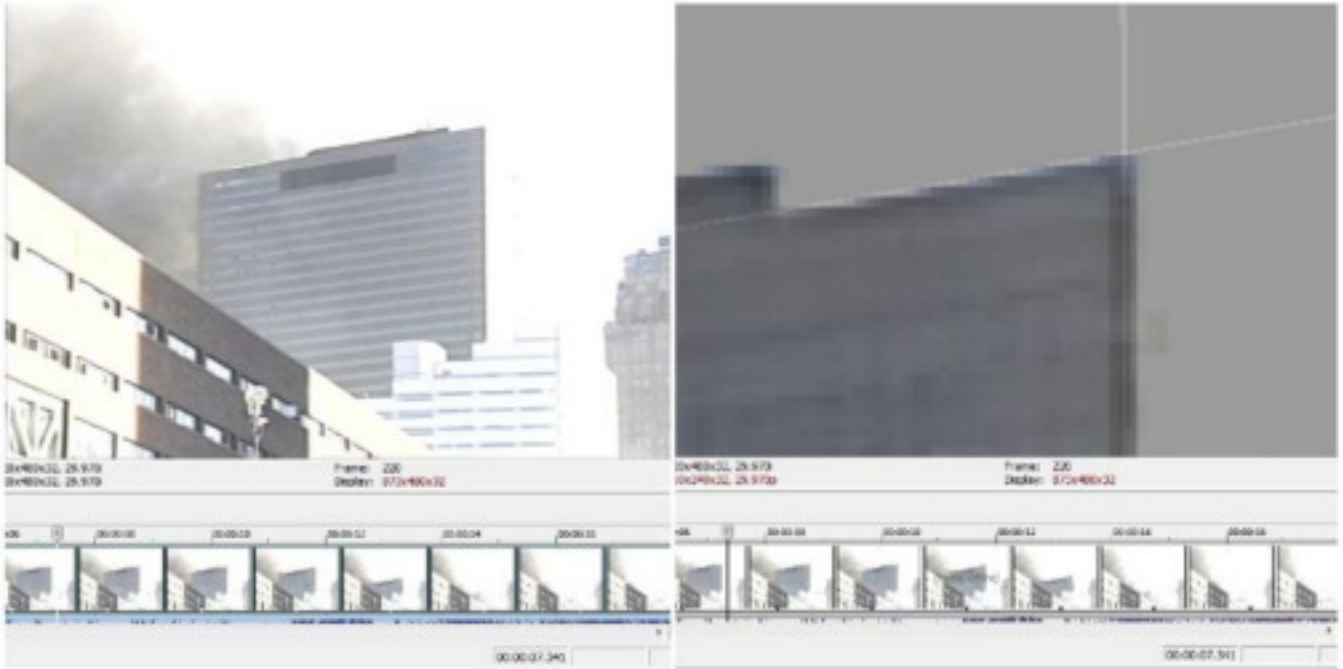
Figure 14 – At frame 220 (7.341 s, NIST "-2.00 s"), the northwest corner has returned to its baseline position.

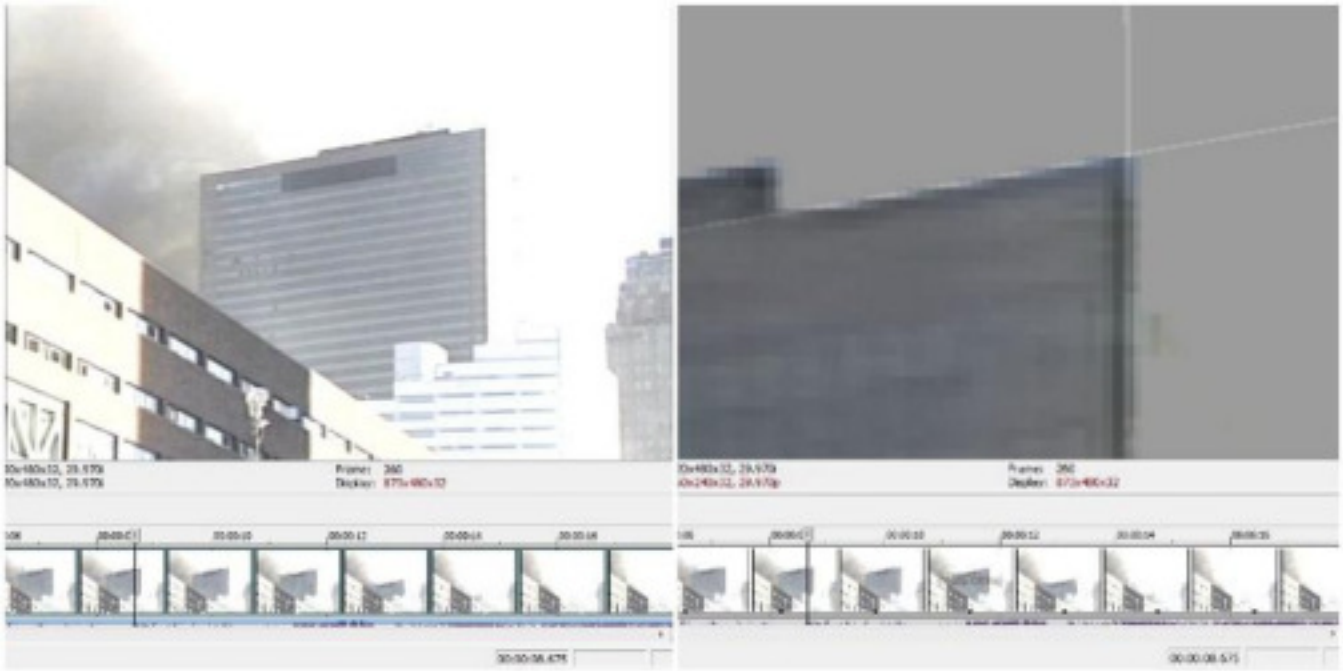
Figure 15 - At frame 260 (8.675 s, NIST "-0.67 s"), the swaying movement has continued, with the northwest corner once again showing eastward displacement.

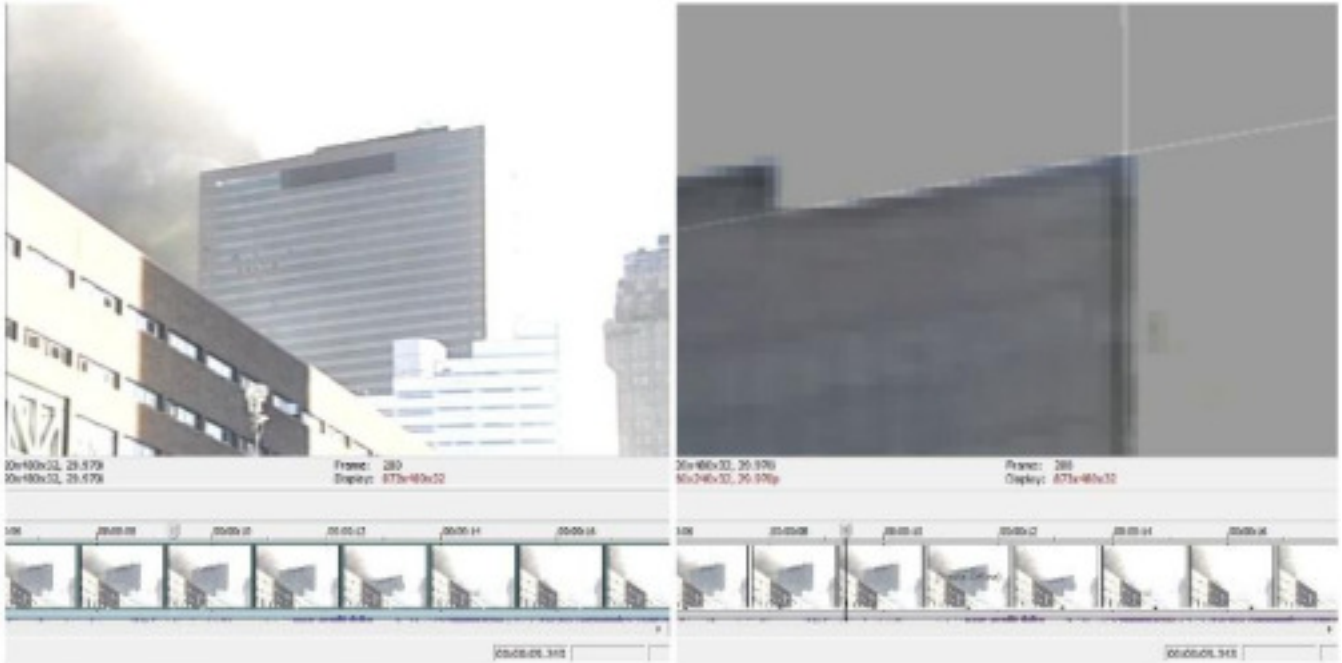
Figure 16 – At frame 280 (9.343 s, NIST's "0.0 s"), there is still slight displacement eastward as the northwest corner is oscillating back to its baseline position.

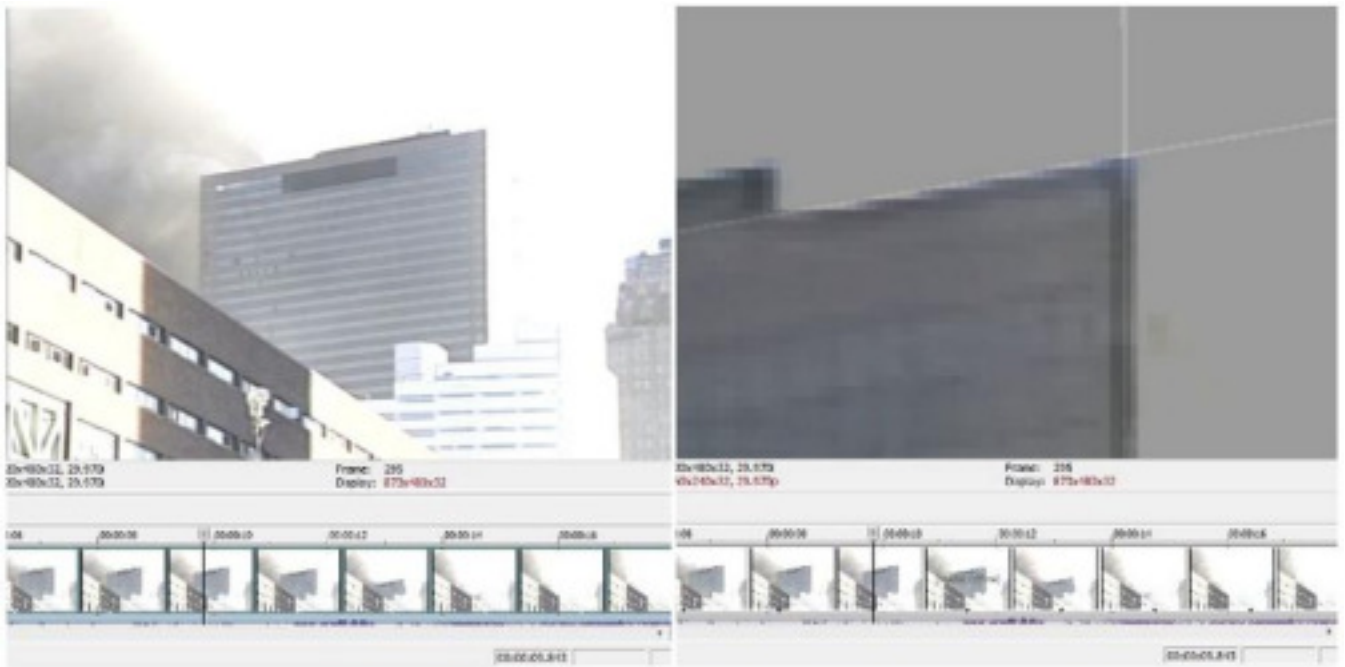
Figure 17 – At frame 295 (9.843 s, NIST's "0.5 s"), the northwest corner has returned to baseline. There remains *no* vertical displacement. Contrary to NIST's claim, although the building is clearly experiencing some kind of shock wave, causing it to sway side-to-side, global collapse is *not* yet underway.

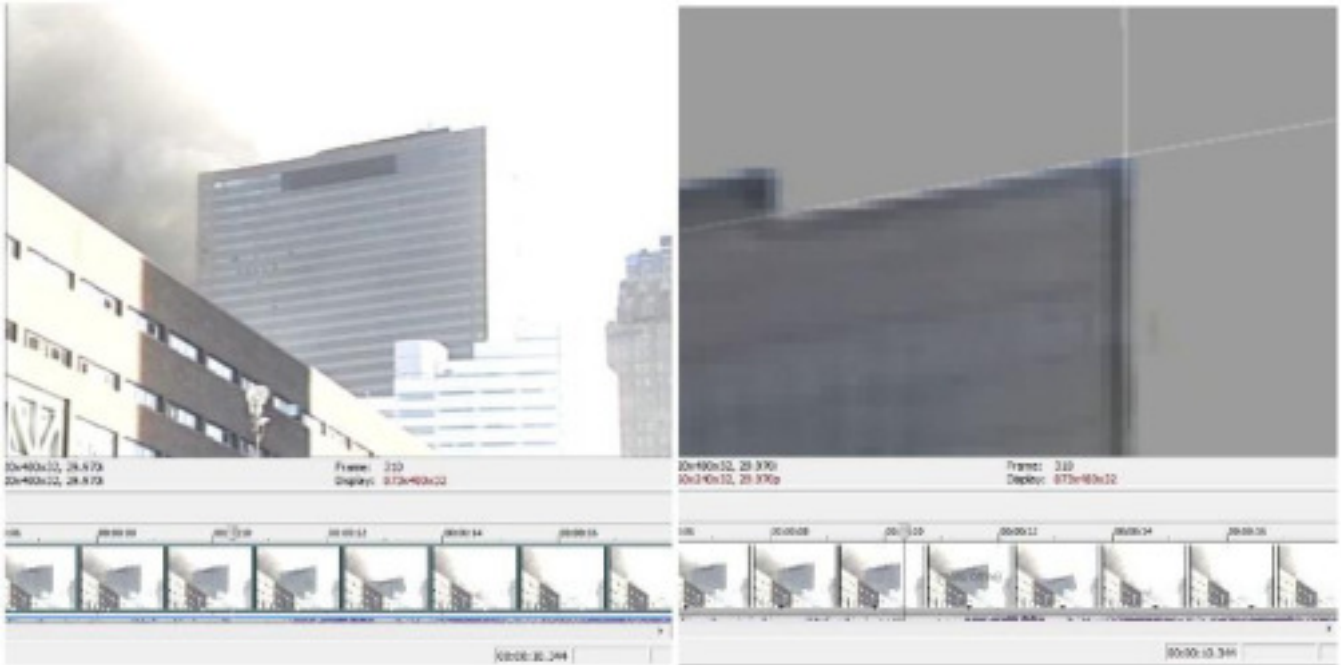
Figure 18 – At frame 310 (10.344 s, NIST "1.0 s"), the building continues to oscillate, with the northwest corner once again showing eastward, but still no vertical displacement.

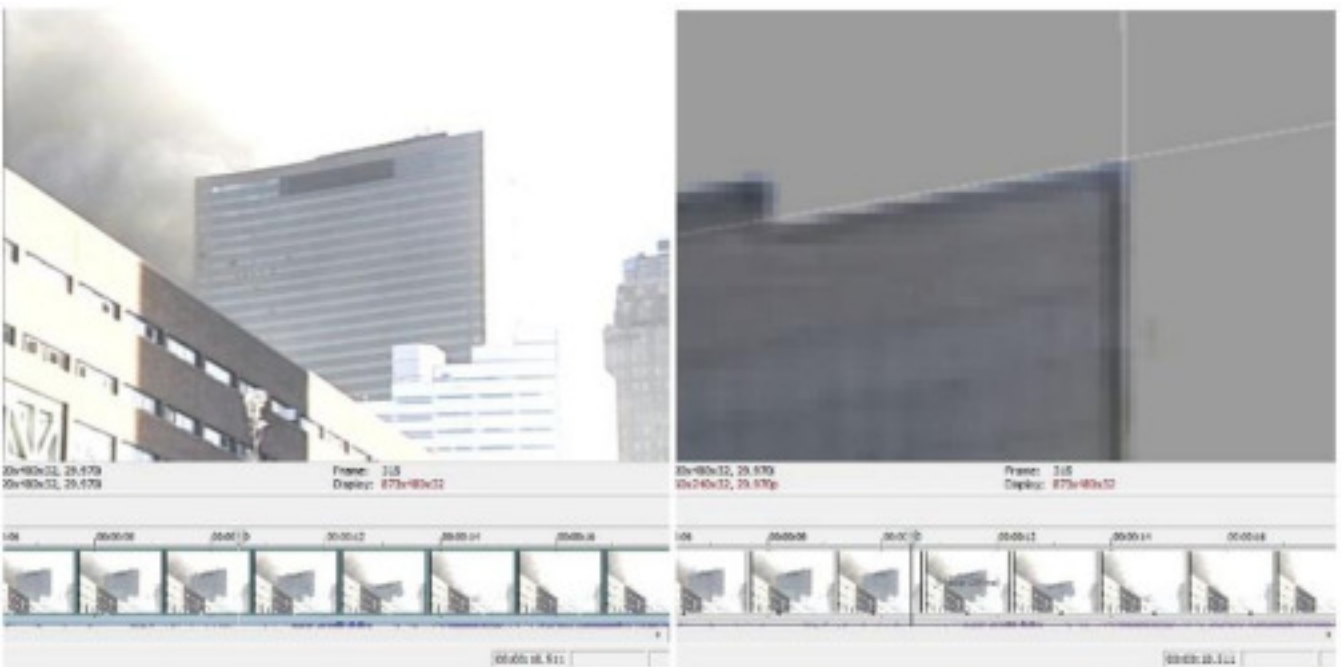
Figure 19 – At frame 315 (10.511 s, NIST "1.5 s"), the eastward displacement is more significant, but there remains no vertical displacement. There is displacement towards the center of the roofline, but this could be attributed to the increasing "pull-in" of the façade.

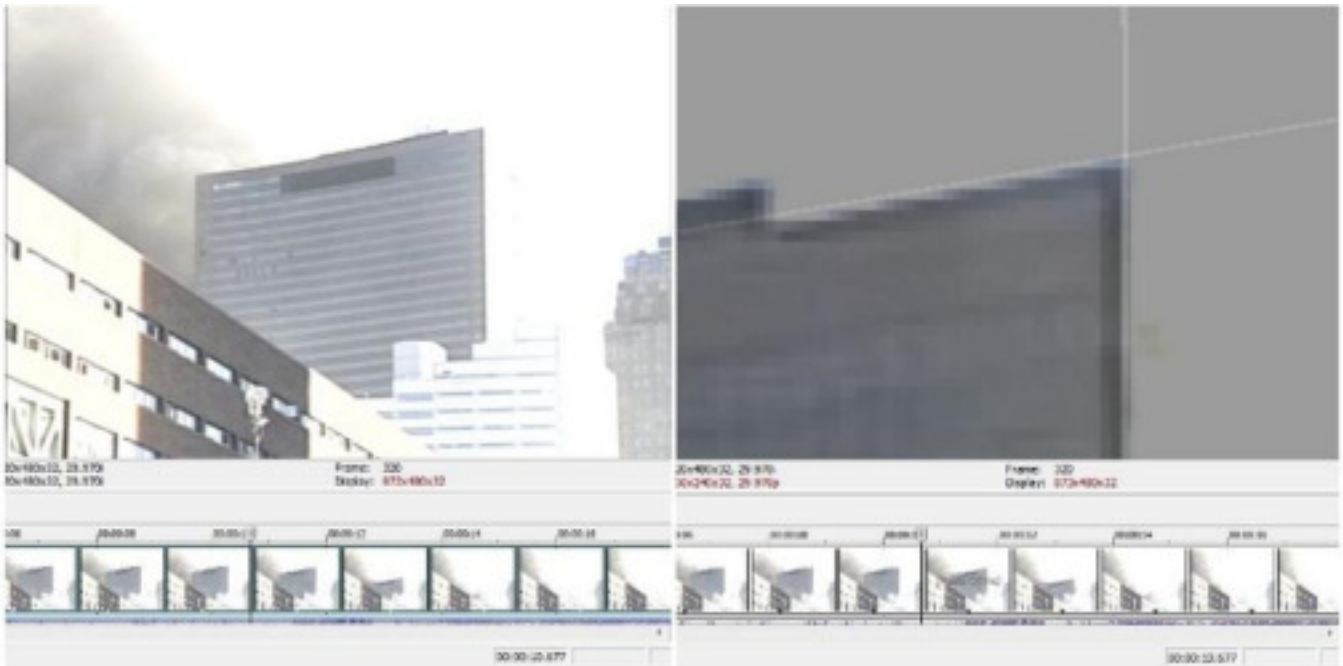
Figure 20 – At frame 320 (10.677 s, NIST "1.67 s"), the displacement of the roofline is significant. The eastward displacement of the northwest corner has continued, though only slightly increased from frame 315. The pixels at the corner of the building have brightened somewhat, but vertical displacement is not unambiguously apparent.

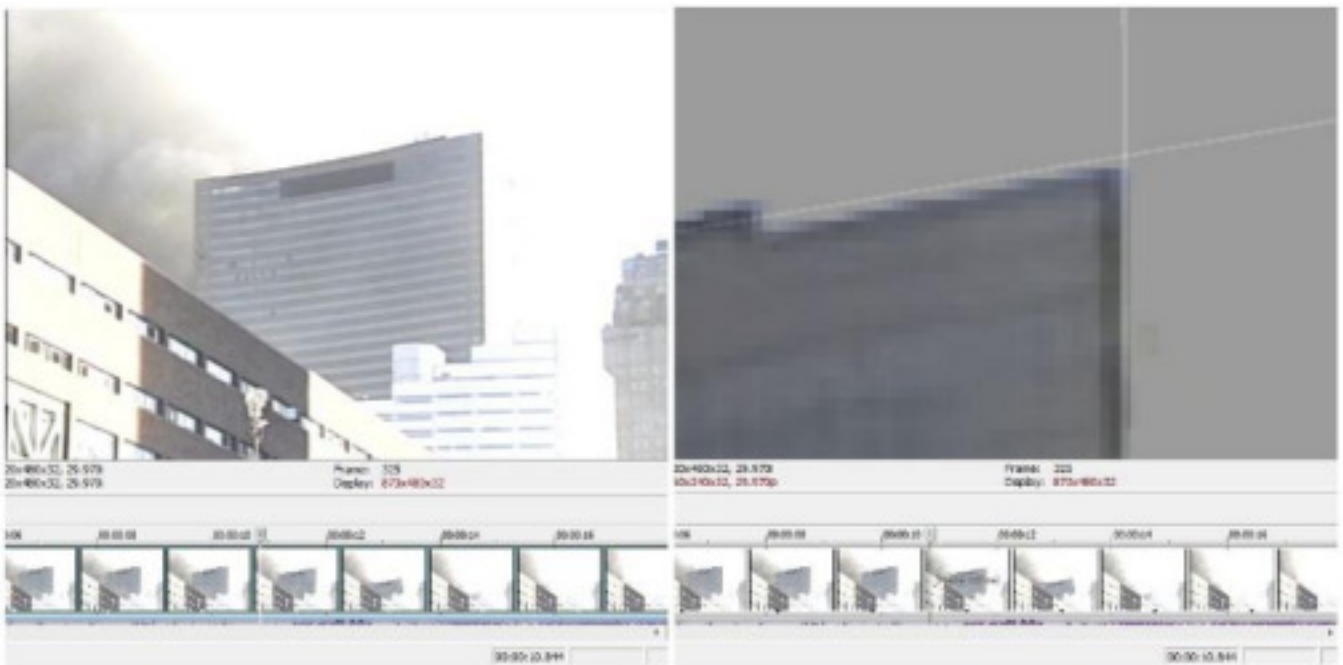
Figure 21 – At frame 325 (10.844 s, NIST "1.83 s"), downward displacement is noticeable. Global collapse is underway.

Stills from frames 310, 315, and 320 show further displacement of the roofline, as well as further lateral displacement of the northeast corner (**Figures 30-32**). Vertical displacement of the northeast corner is not observed until frame 325 (**Figure 33**). This corresponds with approximately the same time vertical displacement of the northwest corner is observed (**Figure 21**).

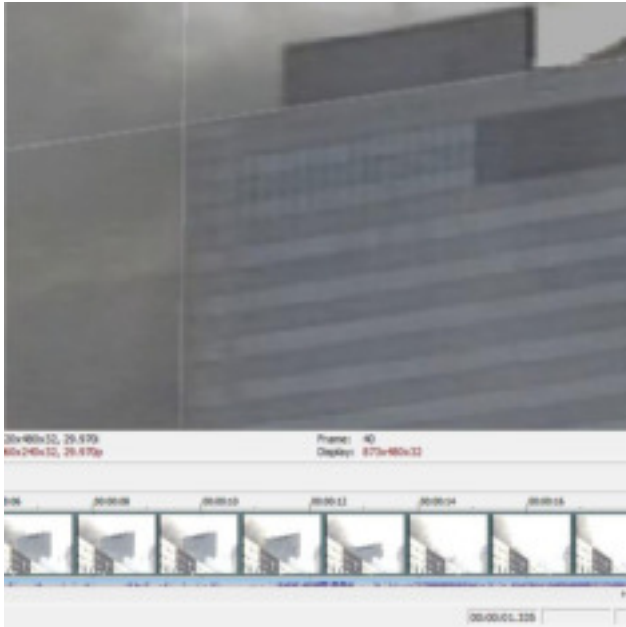
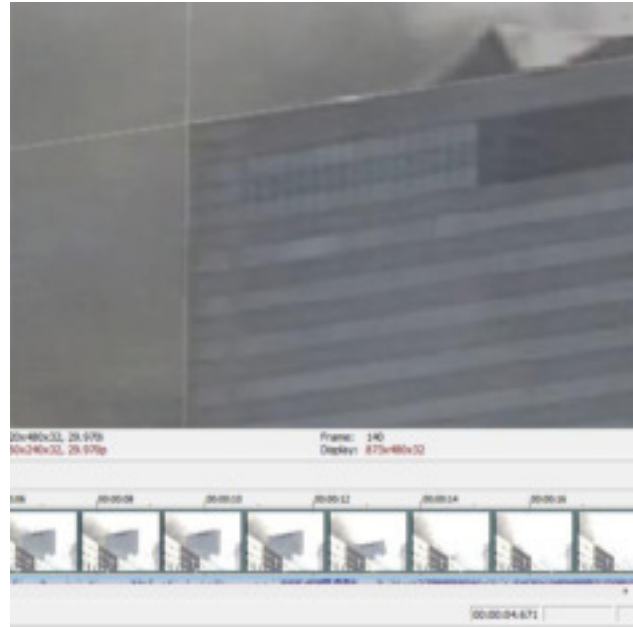
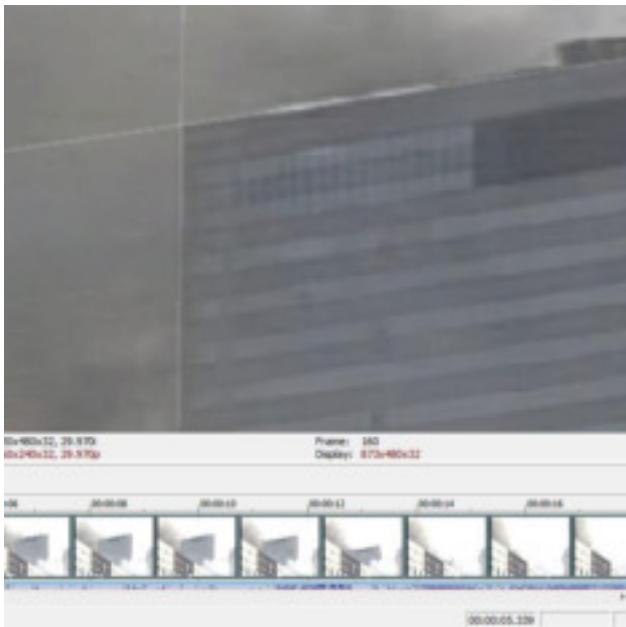
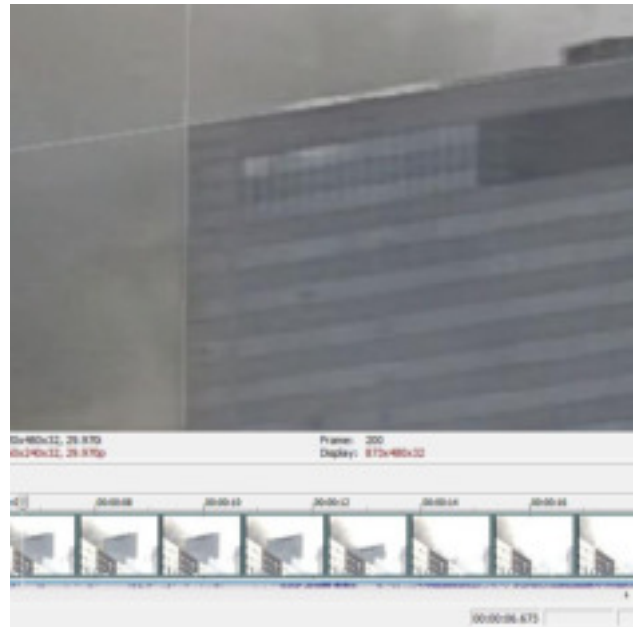
Further observations were made of the northeast corner at the same time intervals. Frame 40 establishes a baseline (**Figure 22**). Frame 140 shows the east penthouse collapsing (**Figure 23**). By frame 160, the east penthouse has disappeared, and the northeast corner is showing lateral displacement that *appears* eastward (**Figure 24**). Interestingly, at this same point in time, the northwest corner is oscillating westward, in the opposite direction (**Figure 12**). This reinforces the conclusion that the *perception* of eastward displacement of the northeast corner is actually due to *northward* displacement. This displacement is slightly more apparent in frame 200 (**Figure 25**).

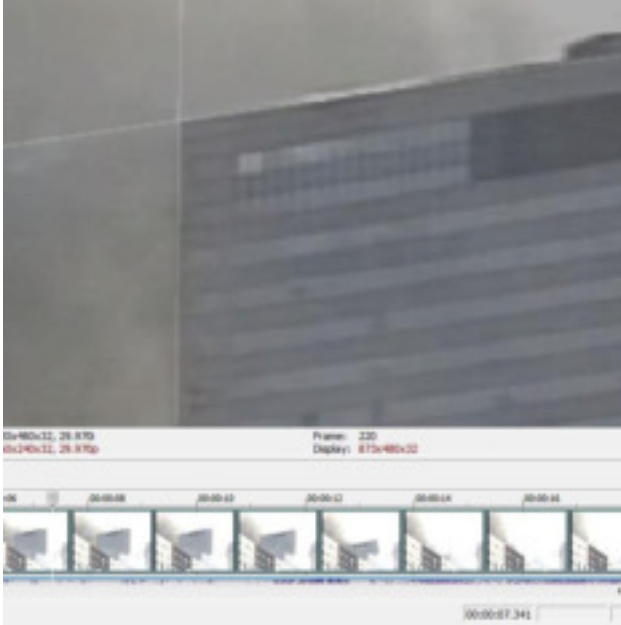
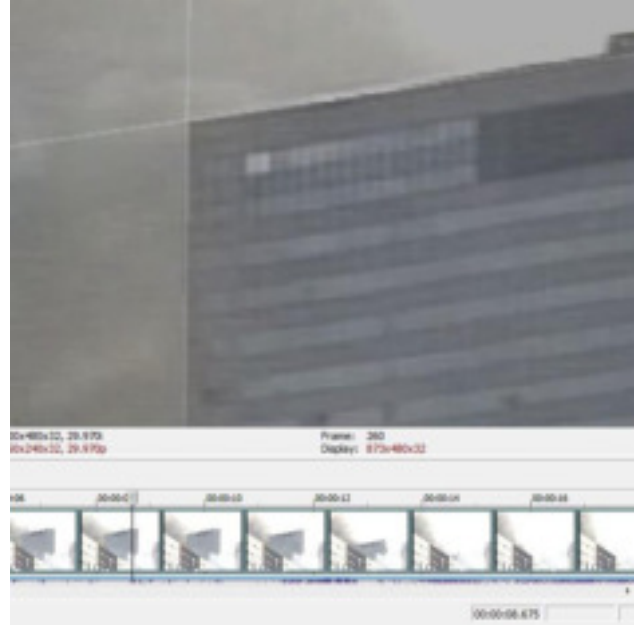
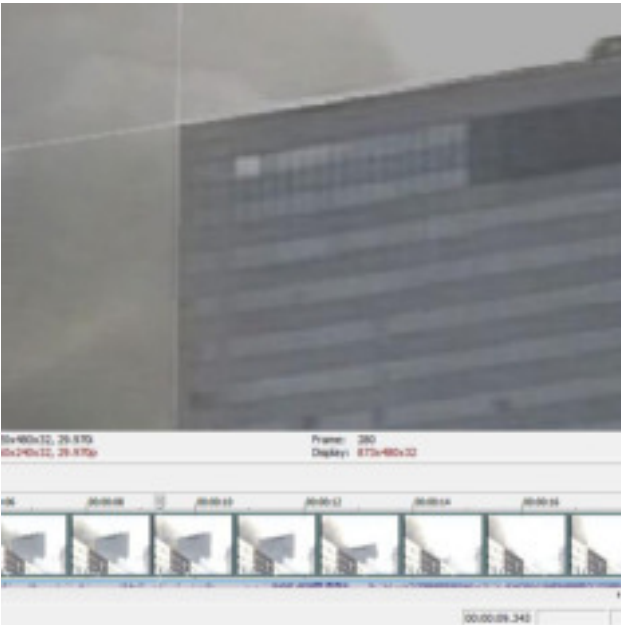
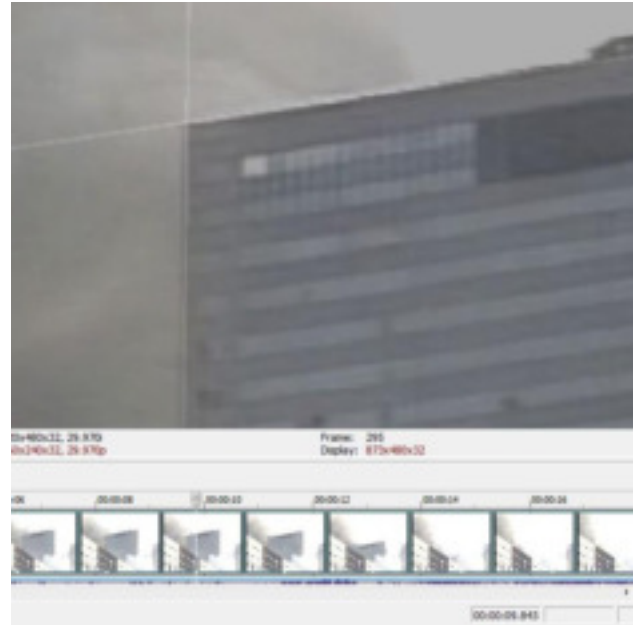
There is little motion of the façade through frames 220, 260, 280, and 295 (**Figures 26-29**). Note that frame 280 is NIST "0.0 s", the ostensible onset of global collapse.
