Video Analysis of NIST's Claim of a 5.4 s Collapse Time Over 18 Stories for WTC 7

Jeremy R. Hammond

July 2011

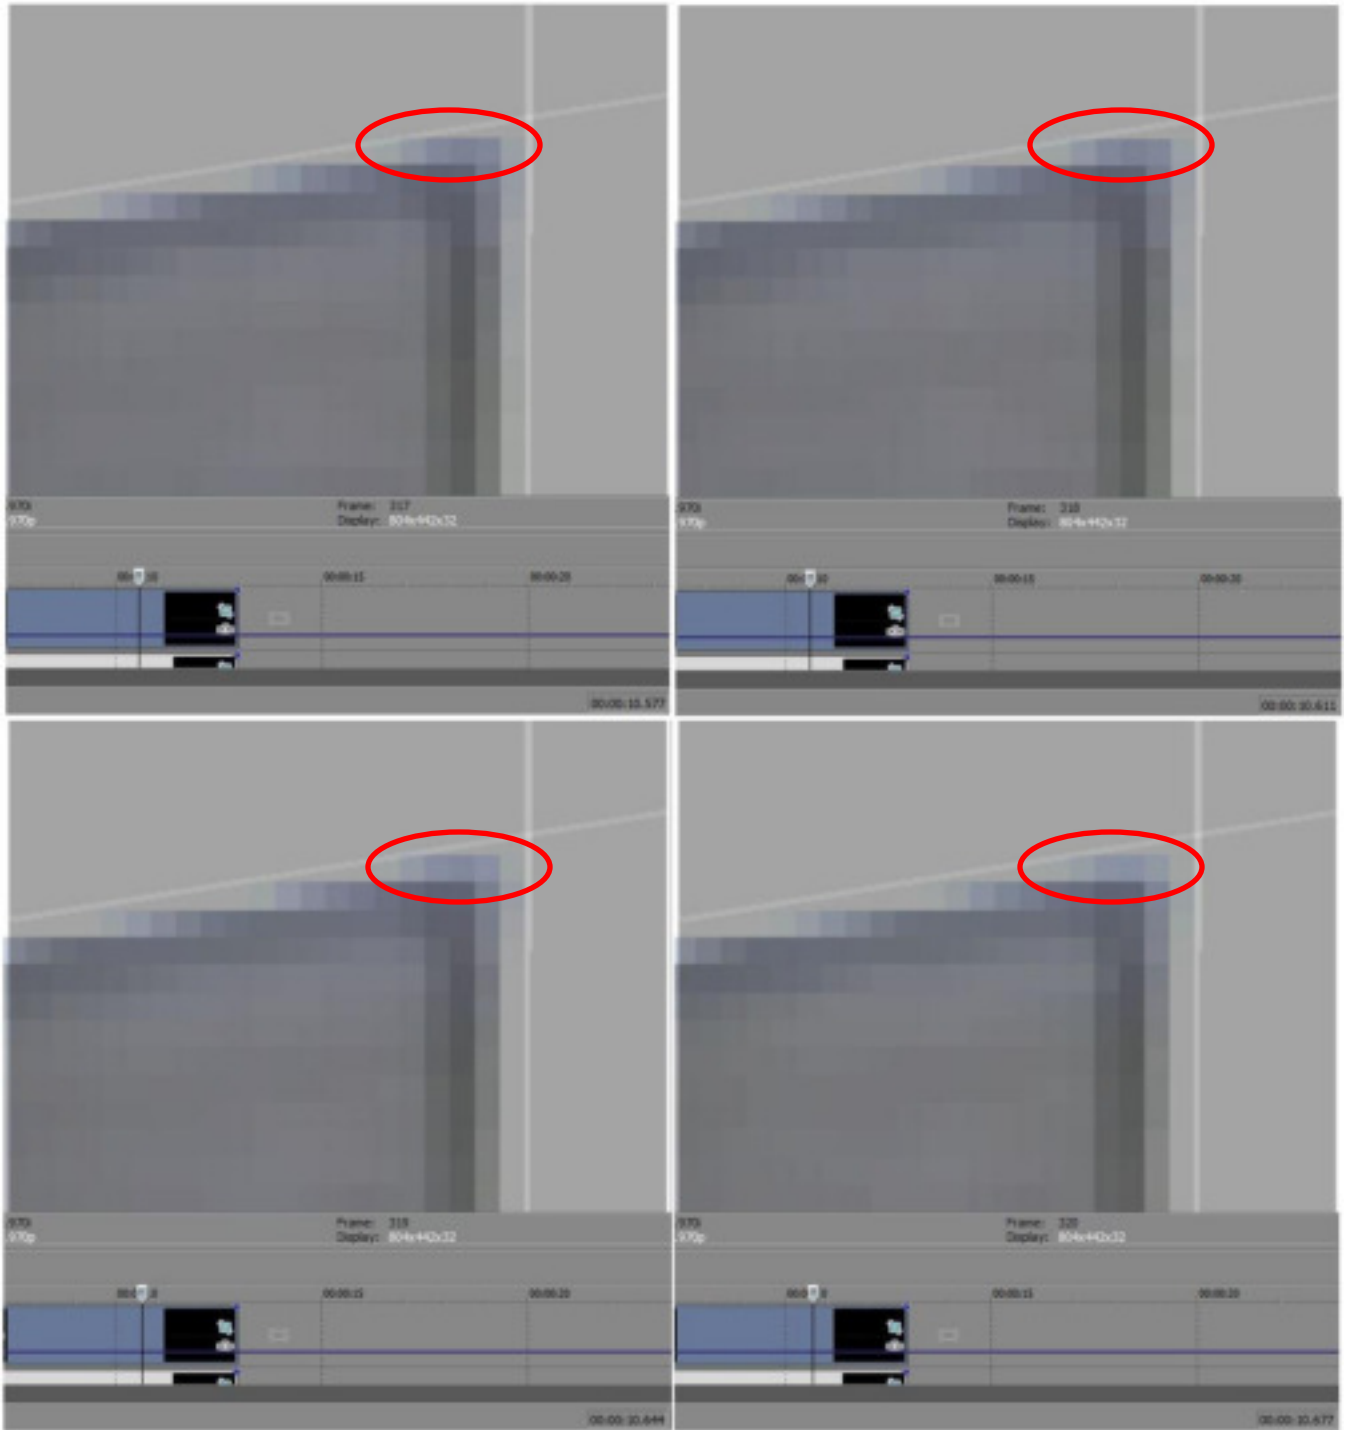
Figure 34 – Frames 317 (10.577 s, NIST "1.23 s", top left), 318 (10.611 s, NIST "1.27 s", top right), 319 (10.644 s, NIST "1.30 s", bottom left), and 320 (10.677 s, NIST "1.33 s", bottom right). No downward displacement is noticeable between frames 317 and 318 (note the similarity in position and brightness of the northwestern-most pixels). The pixels can be observed to brighten significantly from frames 318 to 320, indicating that the building is collapsing. Thus, frame 318 is determined to represent the onset of global collapse, 1.27 s after NIST claims collapse had already begun.

A more scientific methodology would have been to examine vertical displacement of *either corner* of the building, with the northwest corner offering the least ambiguous location from which measure *downward* displacement (it is the displacement of the northwest corner that David Chandler chose to measure in performing his analysis calculating the rate of downward acceleration). Doing so, it can be observed that it is not for approximately one and a half seconds *after* NIST claims global collapse has begun that the northwest corner begins to fall. Using a similar methodology of examining for the brightening of pixels, but instead observing downward displacement of the northwest corner, results in an overall collapse time of 4.13 seconds for the first 18 stories.
